Adaptive Lake Management Plan

**Black Otter Lake District
Hortonville, Wisconsin**

STS Project No. 200800520

STS in Cooperation with Wisconsin Lake & Pond Resource LLC
Last Revision June, 2008

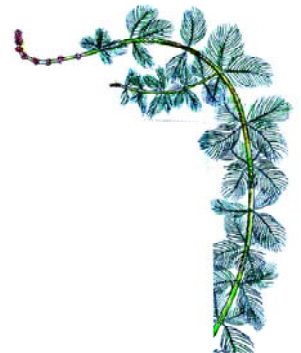
Eurasian watermilfoil (*Myriophyllum spicatum*) produces long spaghetti-like stems that often grow up to the water's surface. Leaves are feather-like and resemble bones on a fish. 3-5 leaves are arranged in whorls around the stem, and each leaf contains 12-21 pairs of leaflets. At mid-summer small reddish flower spikes may emerge above the water's surface. Perhaps the most distinguishing characteristic though, is the plant's ability to form dense, impenetrable beds that inhibit boating, swimming, fishing, and hunting.

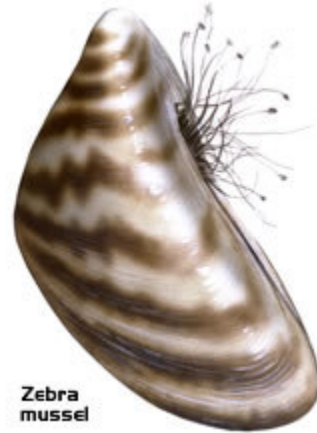
Zebra mussels (*Dreissena polymorpha*) are small (1/4" to 2") mollusks with elongated shells marked by alternating light and dark markings. They produce dense elastic strands, called byssal threads, by which they can securely attach to nearly any surface, often forming barnacle-like incrustations. Mussels spawn in the early spring when water temperatures reach 54° F. Fertilized eggs develop into microscopic free-swimming larvae called veligers. After three to four weeks, the surviving veligers settle onto firm objects where they quickly attach themselves. Within a year the young grow into adults that can live four to six years.

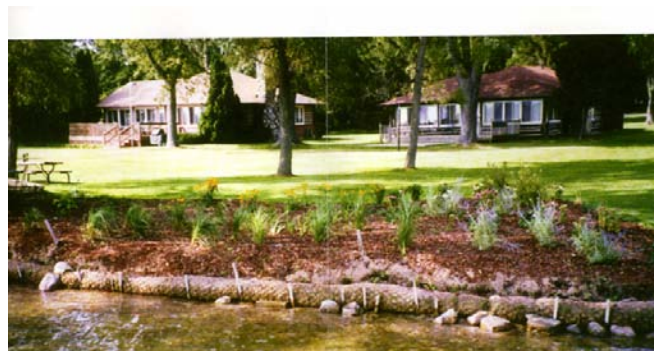
A recommended buffer zone consists of native vegetation that may extend from 25 – 100 feet or more feet from the water's edge onto land, and up to 50 feet into the water depending upon water depth. The buffer should cover at least 50%, and preferably 75% of the shoreline frontage (Henderson, et al., 1998). In most cases this still allows plenty of room for a dock, a

swimming area, and lawn. Buffer zones are made up of a mixture of native trees, shrubs, upland plants, and aquatic plants and are quite aesthetically pleasing.
